Smart Interventions -R&L mis-reporting

13th June 2018

For Information Only

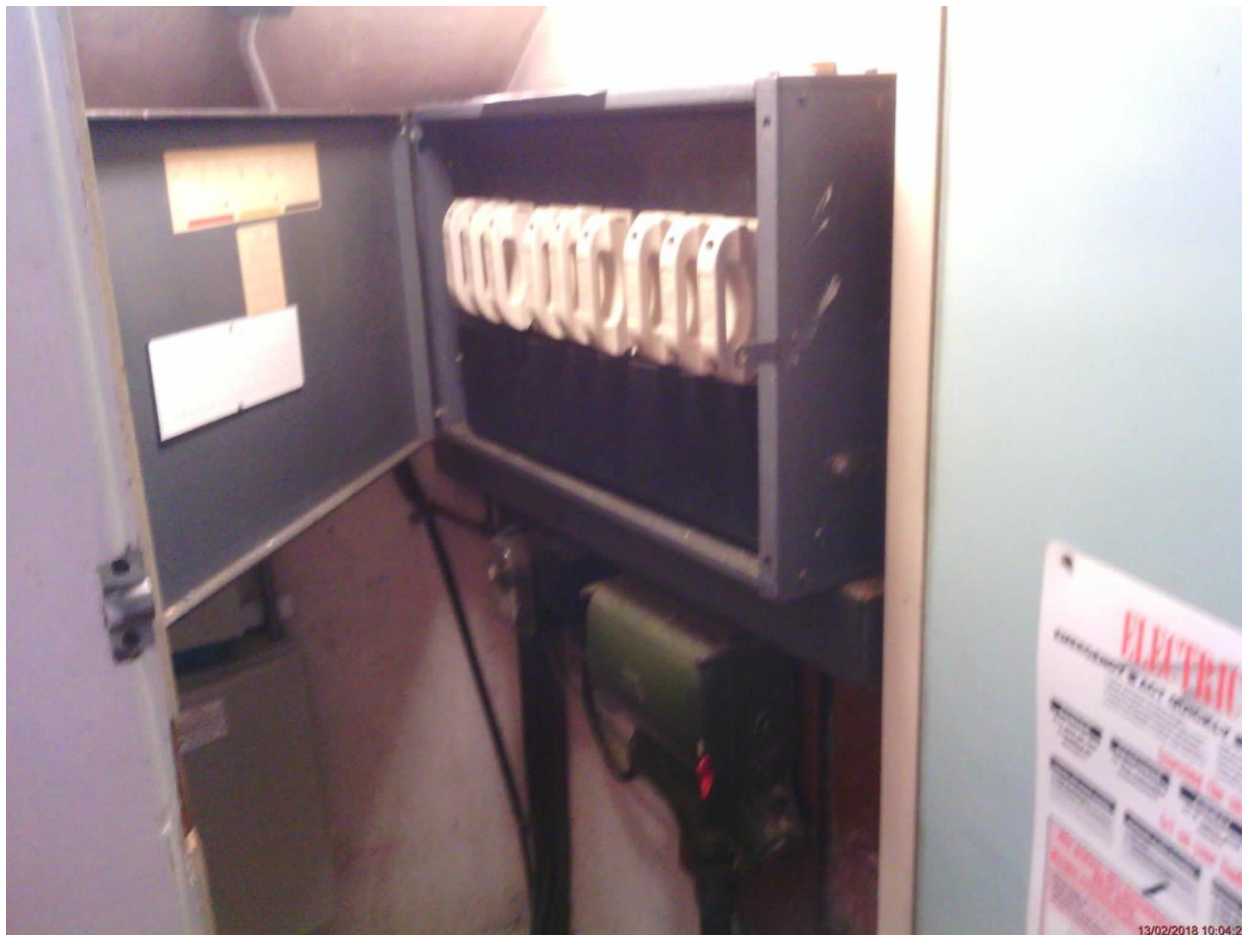
Ryefield Distribution Board feeding flats

The cut-out underneath would not be touched for individual meter isolation.

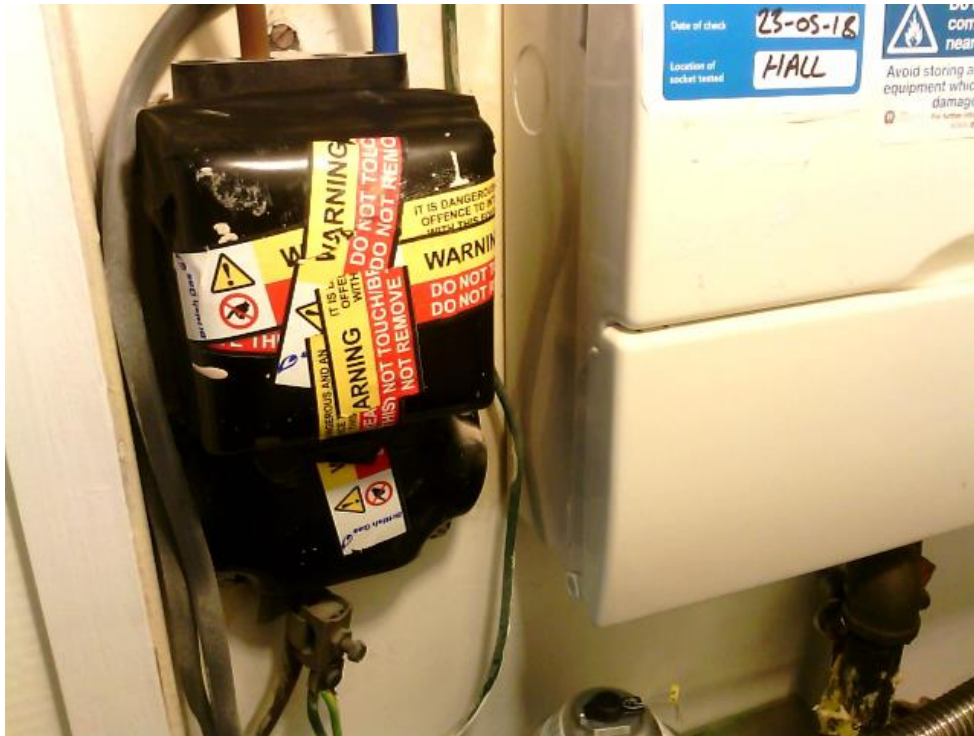
First floor flat fed from riser
the riser is isolatable from the
DNO cut-out on the ground
floor

Worth noting that DNO services
will be mainly on ground floor.

Many examples of services in a
basement area where this reduces
the length of the service cable

A lottery winner might find one
above ground level and would
have extra structural protection
and only if it was environmentally
unsafe for it to be located on
ground floor.

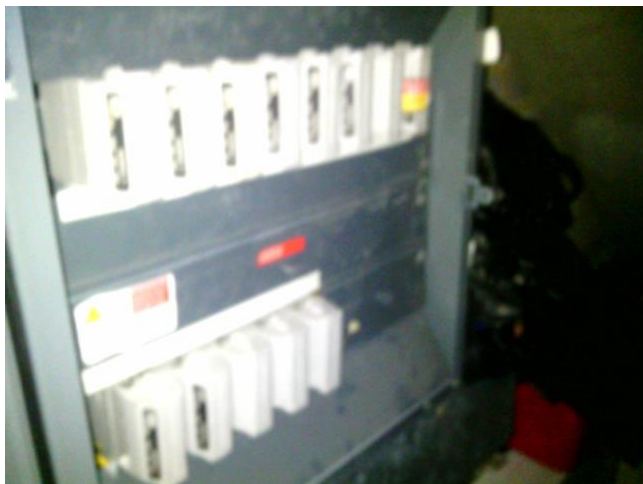
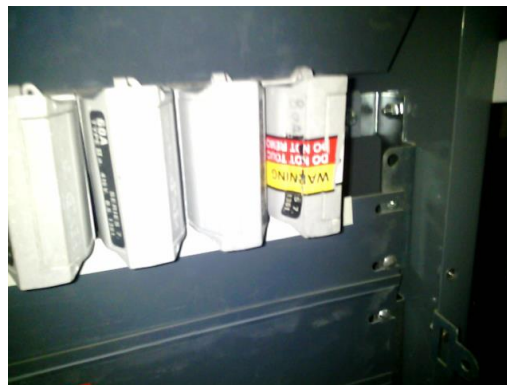
200 amp feeding
rye field
distribution board

Series 7 fuse in
distribution board
contacts broken

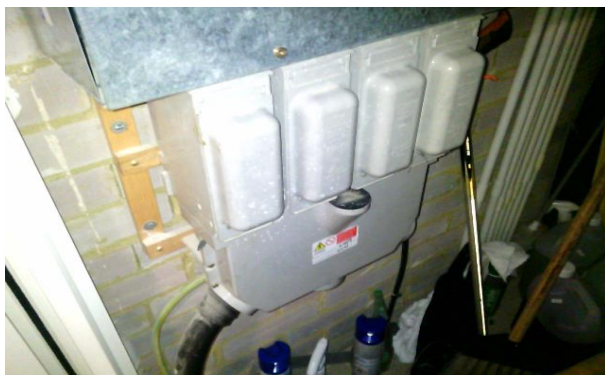
The rye field board
is not UKPNs

The 200 cut-out is
perfectly fine.

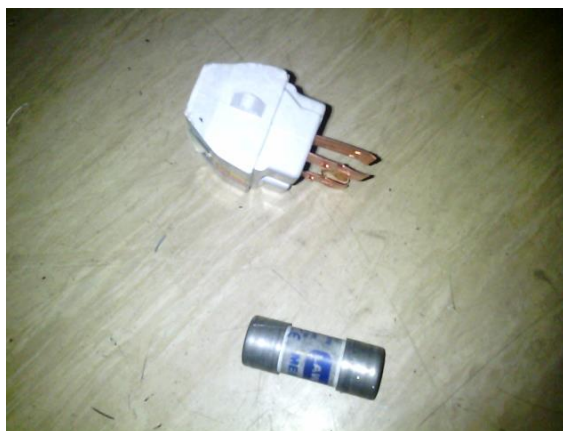
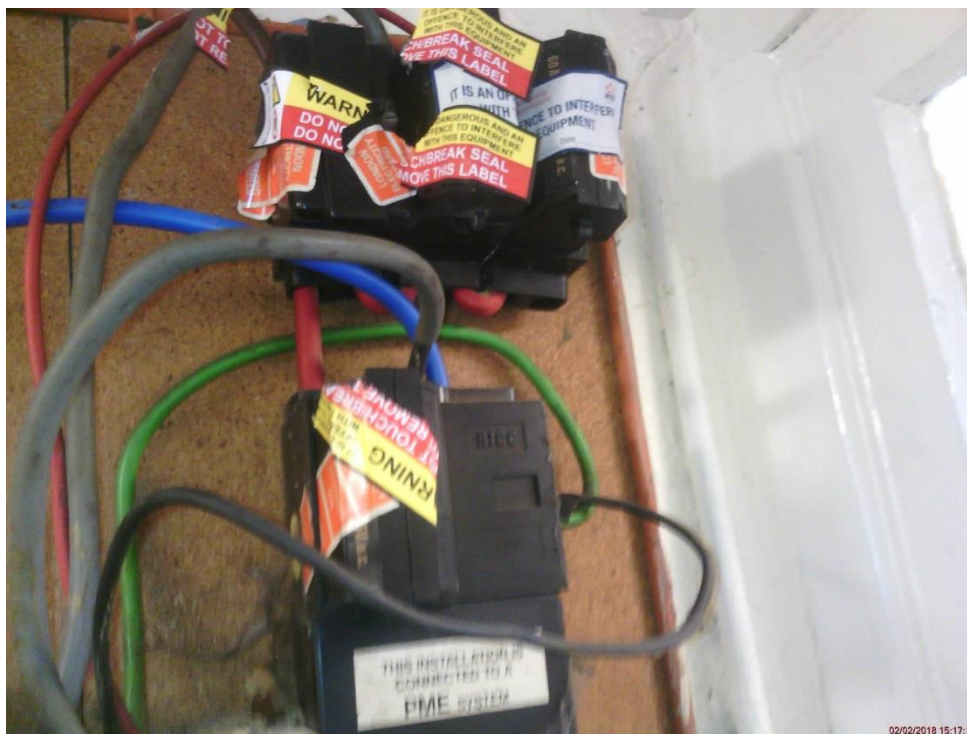
The additional fuses above should either be as part of a distribution board and enclosed

We wouldn't generally recommend more than 2 * 60 a from one 100 a fuse.

A DNO network solution would be at the cut-out.

Secondary fuses are generally the responsibility of the customer

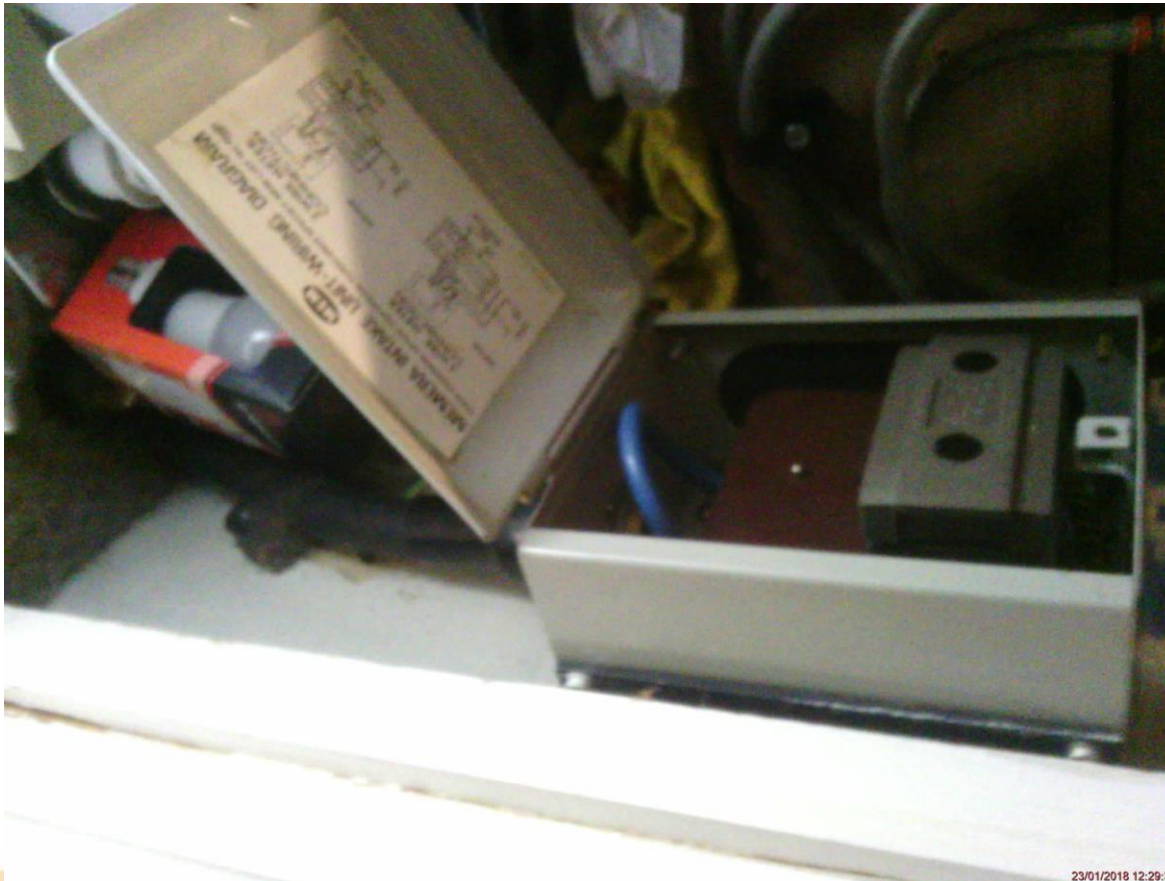
Private ceramic
fuse in metal
enclosure

Not UKPN
equipment

The fuse in the enclosure
was actually fine when
seated properly

Double strike - not UKPN
equipment and meter
could have been installed

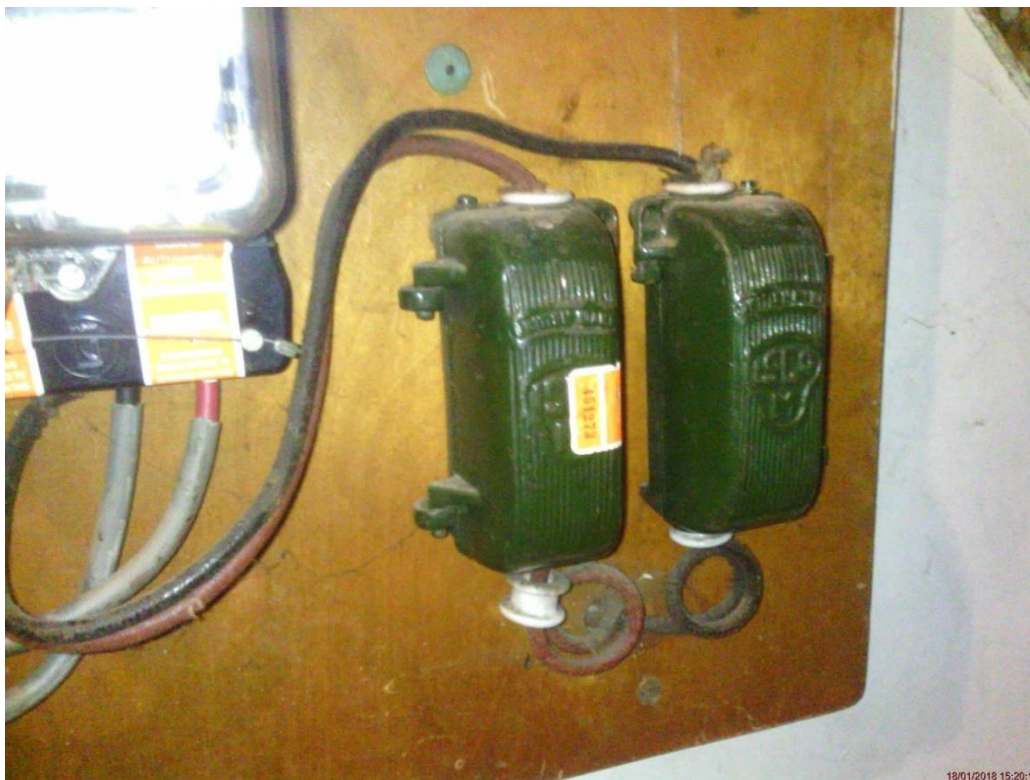
Note the VIR lateral to this equipment

These are secondary isolation points.

Similar DNO Cut-outs would have a sealing chamber and be fed via a PILC cable for underground networks.
