## Category A- Emergency

Asset Condition Code	Code Description
A04	Physical damage to cut-out/service cable requiring immediate action

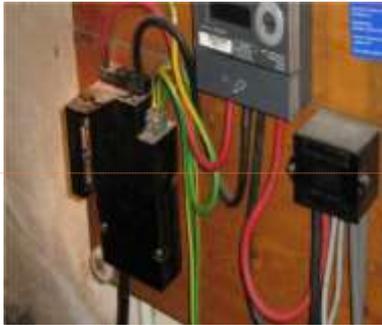
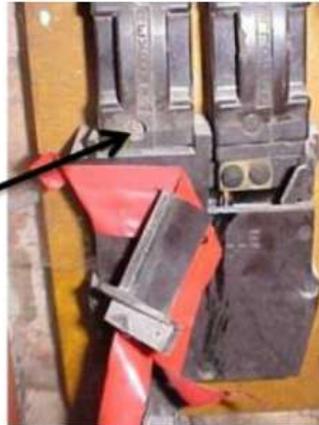
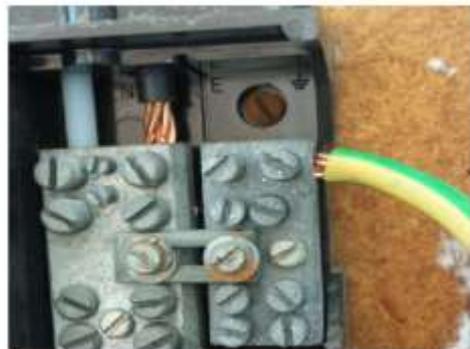
#### Black Plastic (Phenolic)

The DB equipment shows signs of damage with the presence of voltage or broken or severely cracked casing. Internal parts may be exposed or there may be the presence of voltage on a black plastic or phenolic cut out. (See detailed guidance below). Examples of damaged cut-outs and distribution boards include:

A potential safety issue has been identified with both single and three phase black Phenolic plastic cut-outs installed by DBs across the UK between 1967 and 1992, whereby the plastic casing can in some circumstances become conductive leading to a risk of electric shock and/ or excessive heat.

- Contact the DB immediately by telephone – report code A04.
- Remain on Site until the DB staff arrive, unless you are satisfied that you can make the service position safe and secure. (Not applicable for surface voltage issues)
- Note that the cut-out or distribution board (but not the service cable) can often be made safe by the use of appropriate voltage rated shrouding – follow your company policy. (Not applicable for surface voltage issues)
- Continue to monitor the situation, and inform DB if situation deteriorates.
- If you choose to leave the Site, make sure you tell the DB that you are leaving and inform the Customer to remain on Site until the DB arrives or until the DB gets in contact to arrange, so that they know to make contact with the Customer for access.

- Before ~~and-after~~ the ~~installation-of-operation~~ of a ~~meter-cut-out~~ - check for surface voltage on the body of the black plastic cut-out using an appropriate contact voltage indicator (do not operate the DB equipment if a voltage is detected).
- If you discover voltage on the surface of the black plastic cut-out then you should:
  - Contact the DB immediately by telephone – report code A19A04 stating surface voltage present on cut-out.
  - Make the Site as safe as is reasonably practicable.
  - Keep the immediate area clear of obstructions and keep everyone at a safe distance.
  - Remain on ~~site-Site~~ until the DB staff arrive.
