Asset Condition Code	Code Description
A07	Exposed live conductors (live or neutral)

Photo examples – Exposed live conductors

Explanation of earthing arrangements

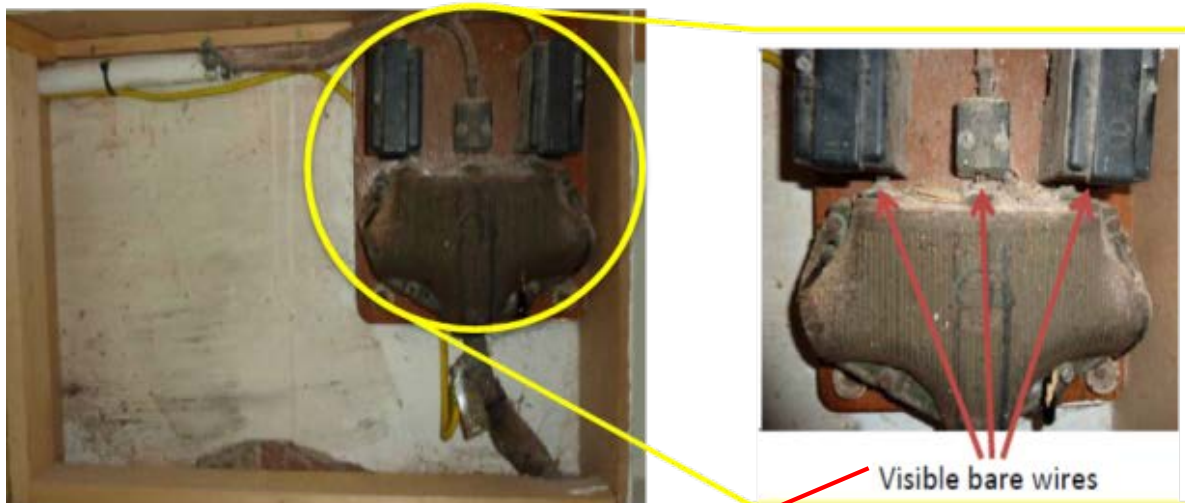
This is an example of a “modernised” cut-out (plastic fuse carriers onto metal encased sealing chamber) showing visible bare wires from the cable termination to the fuse unit. This poses danger if the live conductors could meet the metal casing of the cable termination.

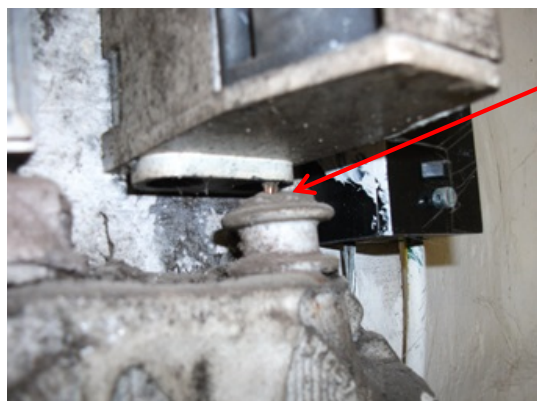
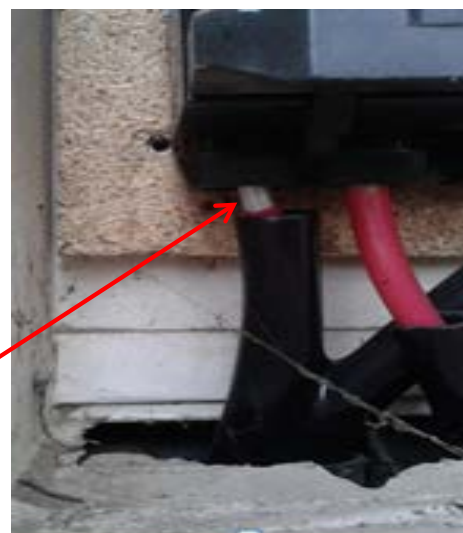
Example of exposed live conductor where the insulated trousers have slipped exposing the live conductor

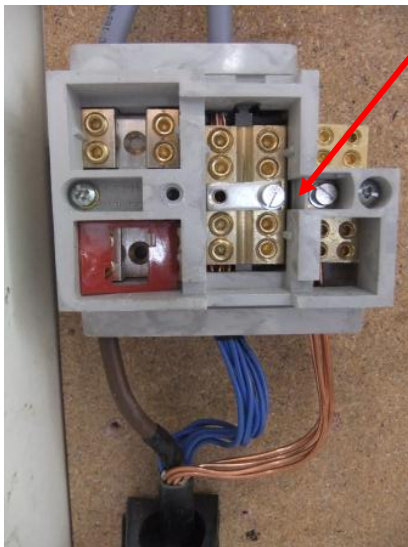
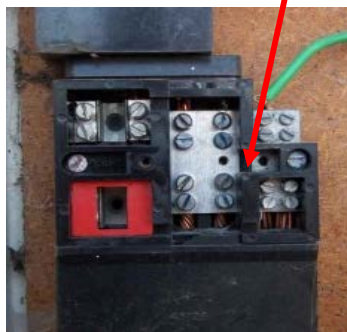
This is where the service cable has a separate neutral and earth conductor at the service position. The earth is usually provided by the metallic cable sheath or a dedicated conductor as part of the cable design. Examples shown below are for presentation purposes only which includes intentional removal of the termination and crutch covers.

SNE arrangement -
Note that the link is removed to provide separate neutral and earth connection

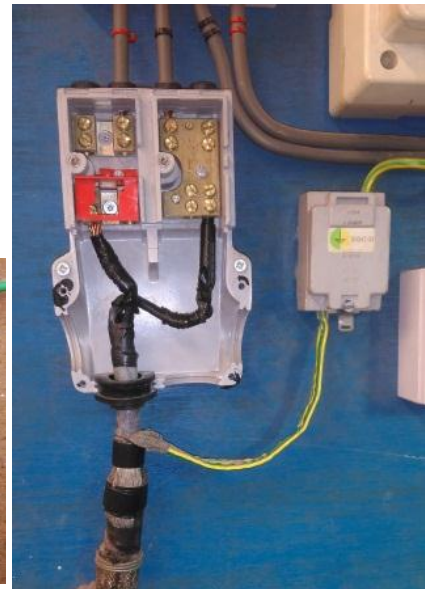
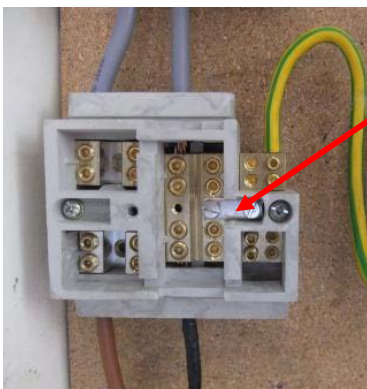
This is where the service has a combined neutral and earth conductor terminated at the service position and bonded to the customer's installation. Examples shown below are for presentation purposes only which includes intentional removal of the termination and crutch covers.

PME arrangement -
Note separate neutral and earth blocks with link inserted to create PME connection arrangement

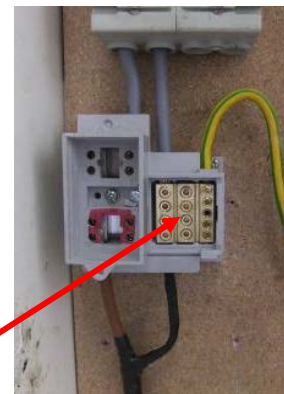
PME arrangement -
Note single connection point for both neutral and earth conductors

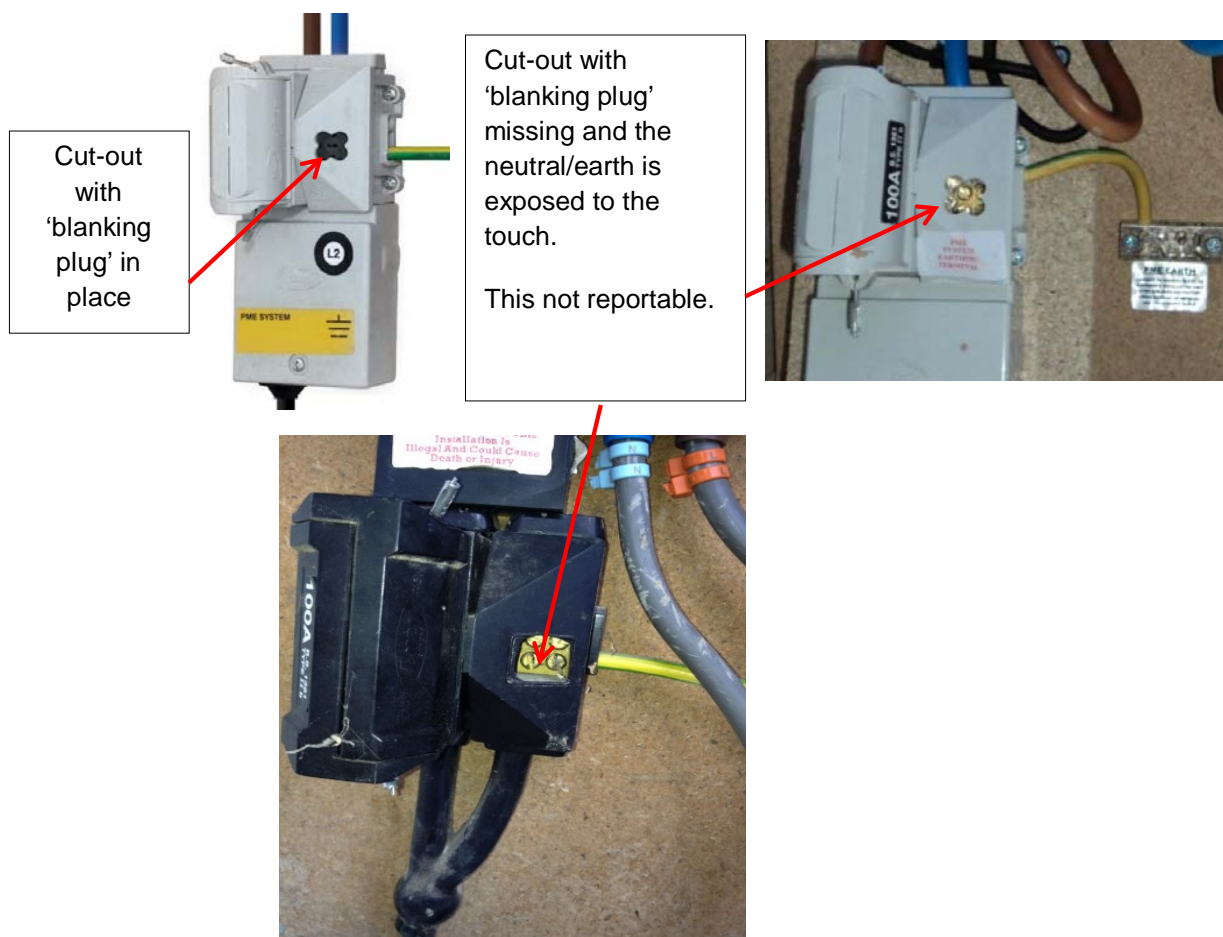
Where cut-outs have missing 'knock outs or blanking plugs' as shown below should NOT be reported as these are specifically designed to provide access to the earth terminal.

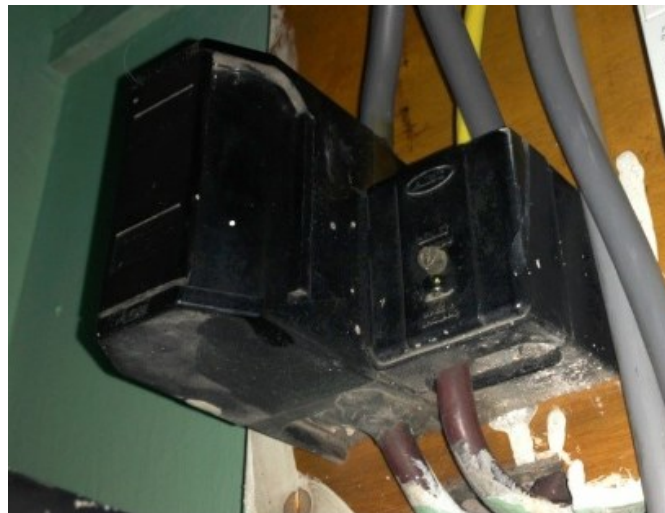
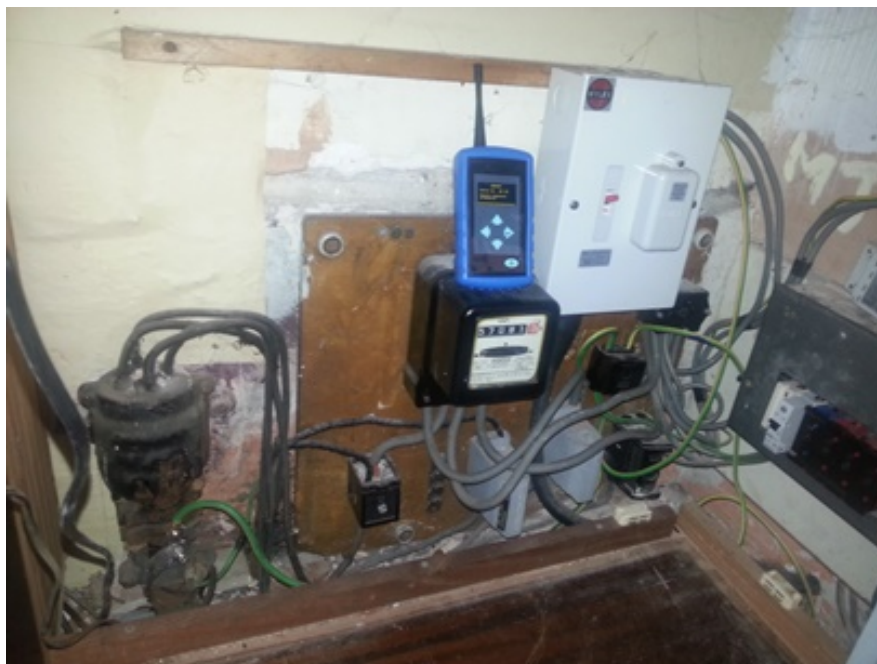
Photo examples – Mineral Insulated (MICC) and Vulcanised Indian Rubber (VIR) cables

- A Mineral Insulated Copper covered Cable (MICC, sometimes known as Pyro).
- A single VIR (Vulcanised India Rubber) conductor.
