## 1. Summary

At the above site, GTC has experienced damaged service terminations, but has identified all remain at risk due to ongoing ground settlement. To ensure we are compliant with our obligations under the Electricity, Safety, Continuity and Quality Regulations (ESQCR) 2002, we are proposing to install a non-standard service termination arrangement on all affected plots.

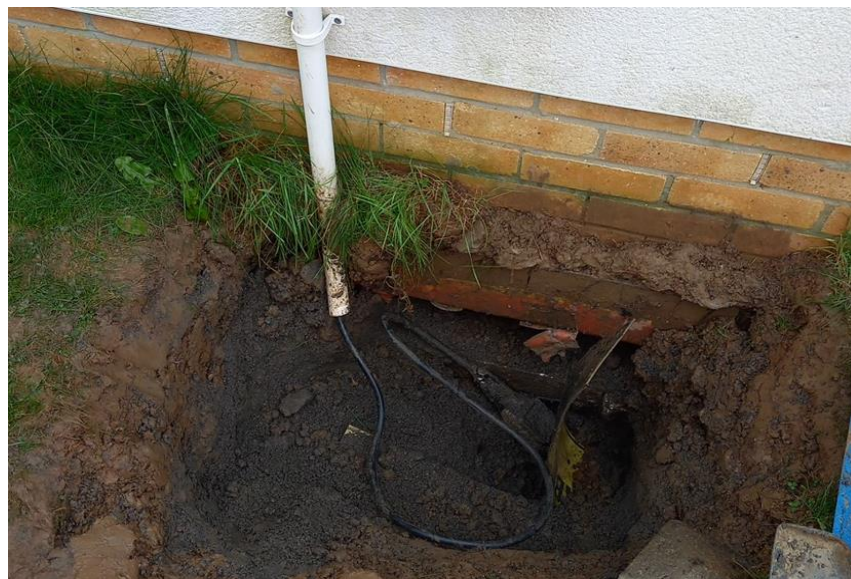
The site build commenced in 2014 by Persimmon Homes split over three phases. In 2017 when phase two commenced, we identified there were issues with ground settlement on phase one. As a result, the then installer decided to retrospectively install a service joint and coil of 35mm<sup>2</sup> service cable immediately beneath the meter boxes on both phases. However, this contingency has proved unsuccessful due to external factors such as inconsistently compressed ground, heavily compacted driveways, cleated hockey sticks and solid core service cable, which is unable to sufficiently flex thereby resulting in damage at service termination positions.

*Figure 2: Service joint and coil of 35mm<sup>2</sup> service cable.*

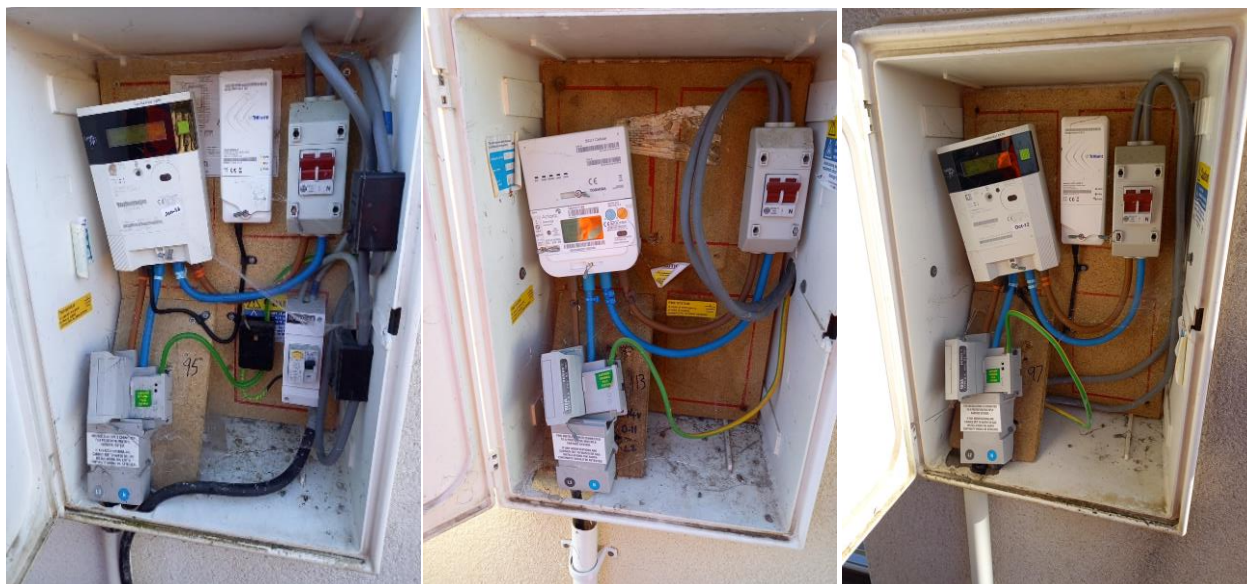
GTC subsequently received calls from concerned customers reporting the damages. Therefore, we mobilised, undertook a full site survey, and found other service terminations in an unsatisfactory state, with live 100amp cutouts and meters pulled away from the meter box backboard.

*Figure 3: Examples of the meters pulled away from the backboard due to tension on the service cables through settlement.*

To ensure our equipment remained safe and operable for customers, we performed an immediate intervention to affected plots as a temporary fix, whilst pursuing a permanent enduring solution, to ensure we remain compliant with ESQCR's by providing our customers with safe and secure electricity supply.

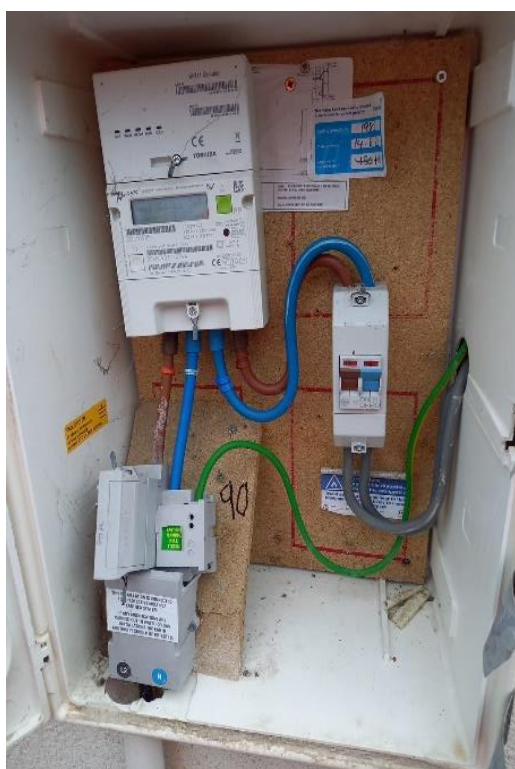
*Figure 4.1: Plot 90 before intervention.*

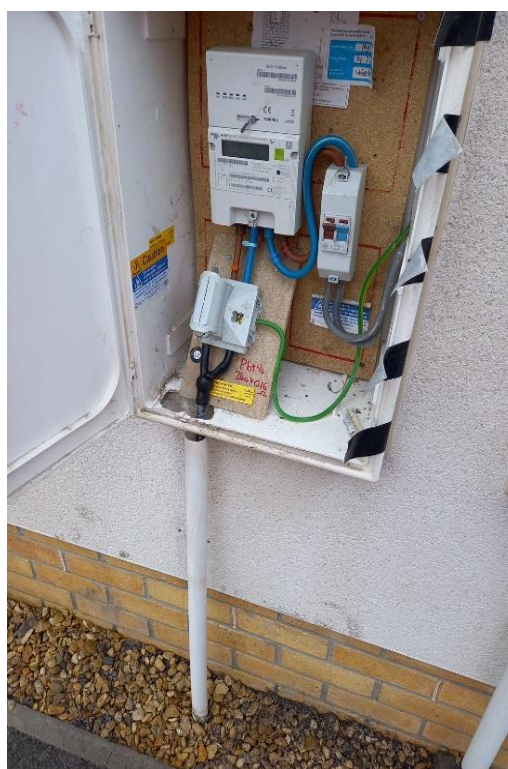
*Figure 4.2: Plot 90 post intervention*

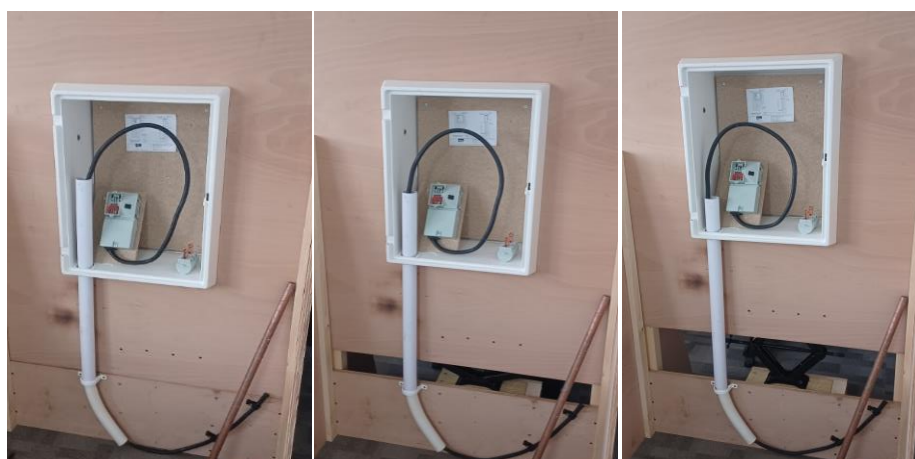
**Figure 5: Trialled solution**

*Figure 5 below is an example which has been trialled within a controlled environment with extreme simulated movement.*

- Cut existing cable below housing and install a new section of cable using a vertical LV straight joint.
- Slide over a piece of white 40mm tube to protect the joint and new section of cable beneath the meter box.
- The additional section of service cable will be a loop inside the meter box, connected to the cutout. The looped cable will provide a contingency for future movement and eliminate the risk of service disconnection.
- Apply a notice/warning sticker to inform third parties of the non-standard orientation.

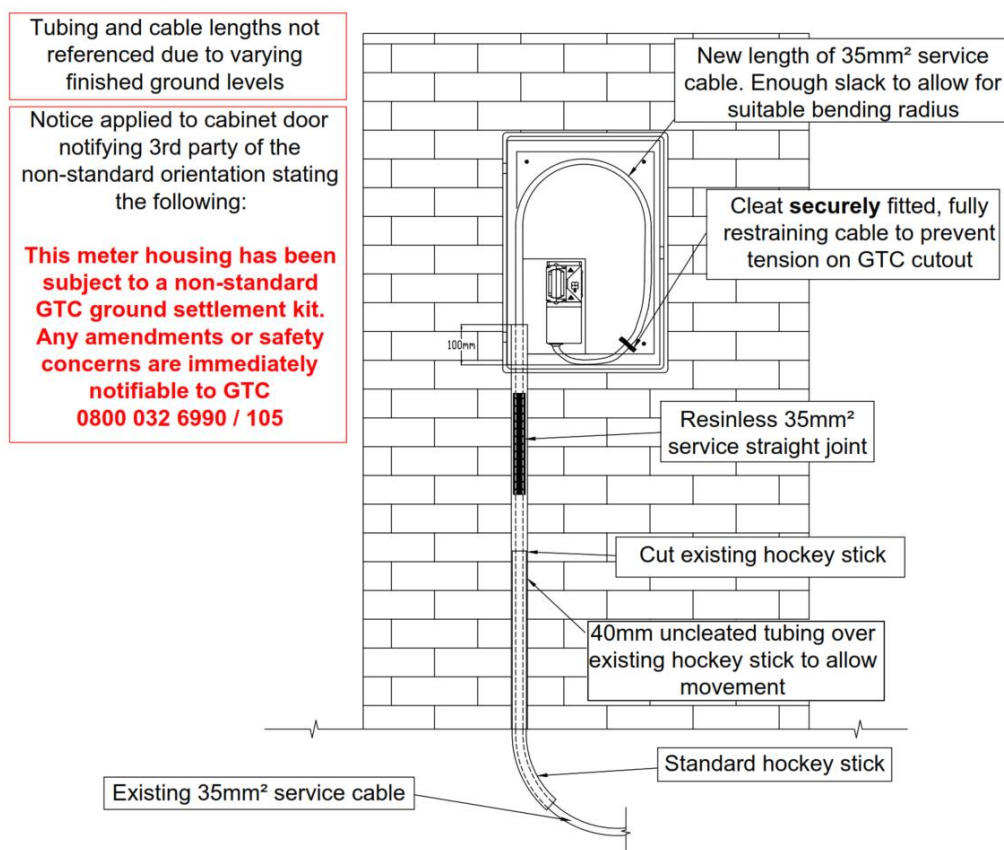
Figure 6: Drawing, settlement kit

Figure 6 is the detailed drawing of the settlement kit:

Note – There may be deviation on the orientation, depending on presence of unauthorised third-party equipment.
