Category B – Remedial Work	
DB work required for you to complete your work	
Asset Condition Code: B07	Code Description: DB equipment issue preventing installation/replacement of meter tails

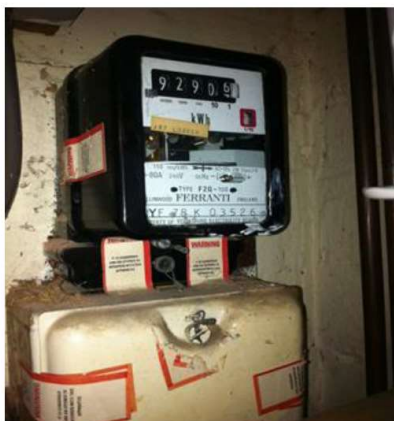
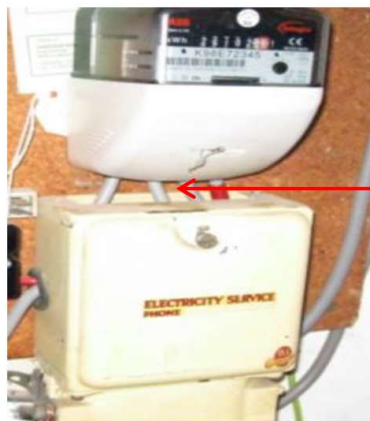
Raised position of meter could create a potential category A issue by leaving exposed live conductor(s) through the cut-out cable entry slot that were previously covered by the meter placed directly on top of the cut-out

- The connection terminals on the outgoing side of the cut-out are unable to accept a minimum conductor (tails) size of 16mm²;
- The connection in the DB equipment is welded in;
- Terminal screws cannot safely be slackened (e.g. neither fixed nor temporary shrouds are available);
- Holes would be left in metal DB equipment if the tails were to be exchanged and grommets or bushes to fill the entry point are not available;
- A meter position change that would create a potential category A issue that was not previously present and cannot be rectified by the Meter Operative e.g. changing the location of a meter which would expose live conductors in the cut-out that were previously covered by the meter (see example below);

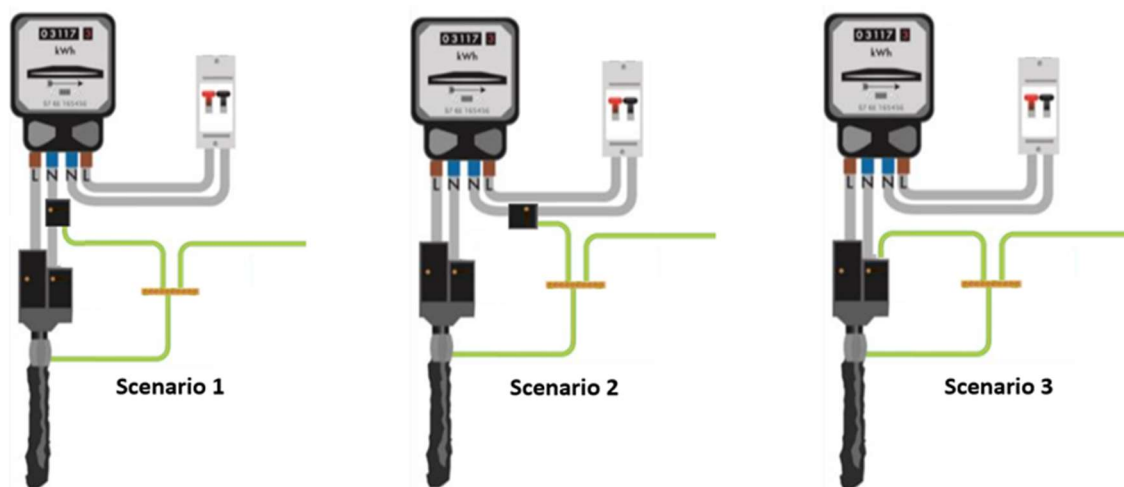
- The incoming neutral is found to be wired directly to the meter with no termination at the cut-out (excludes supplies provided by rising mains and lateral services, see section below);
- There is (not immediately hazardous) debris within the cut-out or distribution board that poses a risk to its safe operation. Use Code A04 to report issues where hazardous debris provides an immediate risk.
- The PME connection arrangement is non-standard as shown in Scenario 1 below. Where the meter neutral tail between cut-out and connector block does not need to be replaced, you do not need to report as Code B07 but continue with your work and report as Code C21.
